South Gippsland Landcare Network's Greening Gippsland's Dams project

Case study: impacts of complete exclusion, restricted and uncontrolled access of farm dams on water security, stock management and biodiversity

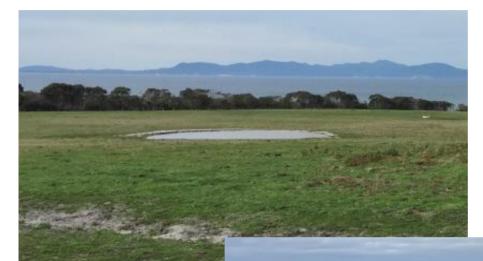
Left: spring-fed dam in 2016

The owners undertook a major subdivision of the Home Farm in 2016 to improve grazing management and protect a spring-fed dam that was suffering erosion. That dam was fenced off from stock and revegetated in 2016. It is the basis of an extensive reticulation system that feeds troughs in every paddock on the Home Farm.

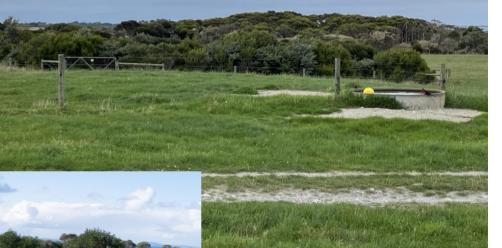
Above: spring-fed (full exclusion) dam in 2024

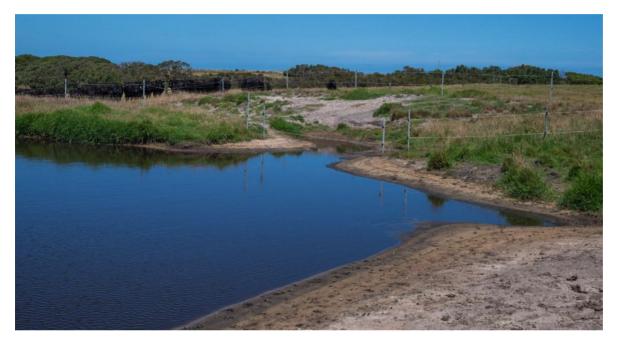
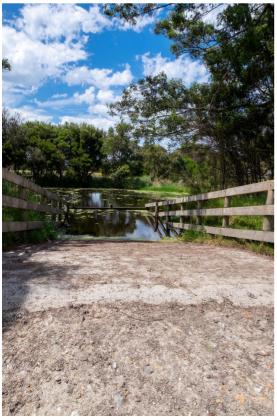
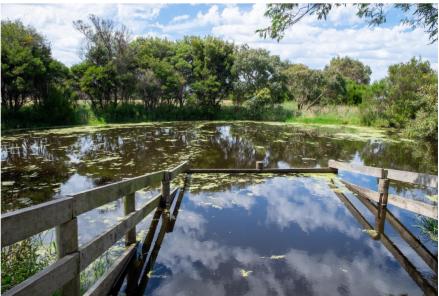
Top: dam on Top Block showing signs of erosion. Above and left: inspiration for restricted access dam (on property previously owned by the Trease family at Inverloch).

The Top Block was acquired in 2018 and the ideal paddock subdivision is still being contemplated. Until this project, all dams on the Top Block were unfenced, suffered some degree of erosion and required regular cleaning. The outflow point of the dam in the paddock that is used for spring calving was at risk of collapsing and the boggy inlet made stock management difficult.

The Top Block is on an incline and this dam abuts the downside fenceline making it difficult to instal a trough and gravity-feed system. The owners were keen to explore a restricted access design for the dam and to compare it with the benefits delivered by the full exclusion dam on the Home Block.

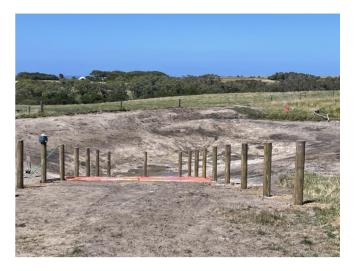
Ramp construction details: 4m wide watering point 25 MPa (megapascal strength) 80 slump (fluidity) 20-25% slope Reinforced with plastic waste Lower planks made of ironwood for water resistance

The entire dam including all the boggy inflow was fenced off using the same mix of plain and electric wiring as the rest of the farm. The dam was then drained and a concrete ramp leading to the deepest point of the dam was built on the most stable section of land. The ramp was fenced using water-resistant hardwood.

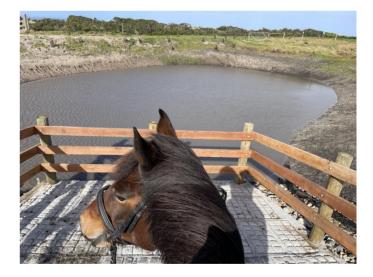
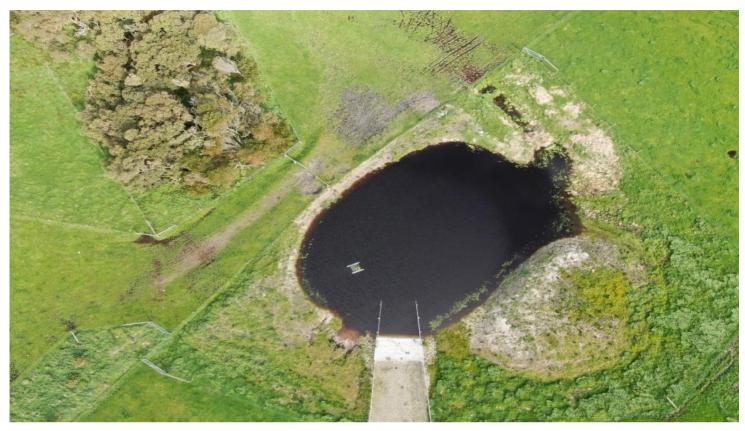
Above: restricted access dam, less than one year after taking action to prevent the dam failing due to erosion at the outflow point (top right). Aquatic vegetation is visible in the shallow margins at the lower and right hand margins of the dam. (Drift Media)

The erosion threatening water security at the outflow point of the restricted access dam ceased immediately after the area was excluded from stock. Similarly, the inflow areas have stabilised. In comparison, erosion around the unfenced dam is worsening.

In contrast, aquatic vegetation is thriving in the full exclusion dam and established itself very quickly in the restricted access dam in the shallow margins and outflow point. Some species were planted by the owners but many regenerated naturally as soon as stock were excluded from the dam banks.
